Appendix A

Yager Creek Subbasin Historical Stream Field Survey Notes

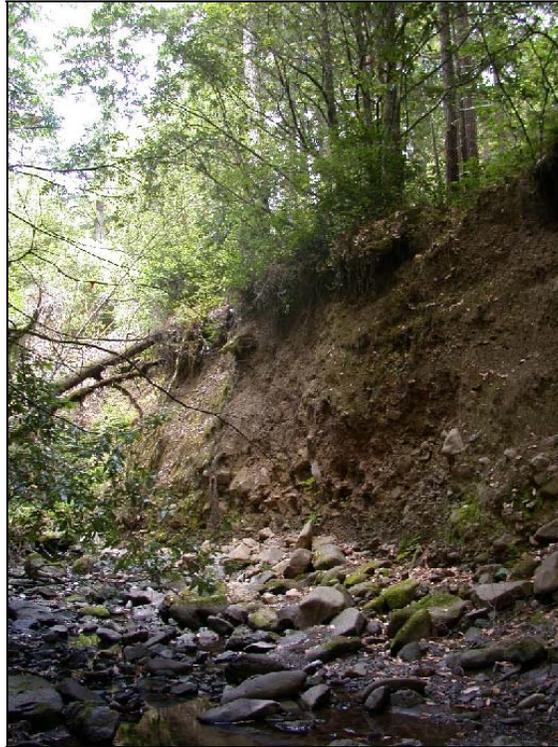
Figure 1. Photo displaying Blanton Creek's armored plane bed channel, bank erosion, intermittent flow and lack of large trees needed for shade and LWD loading.

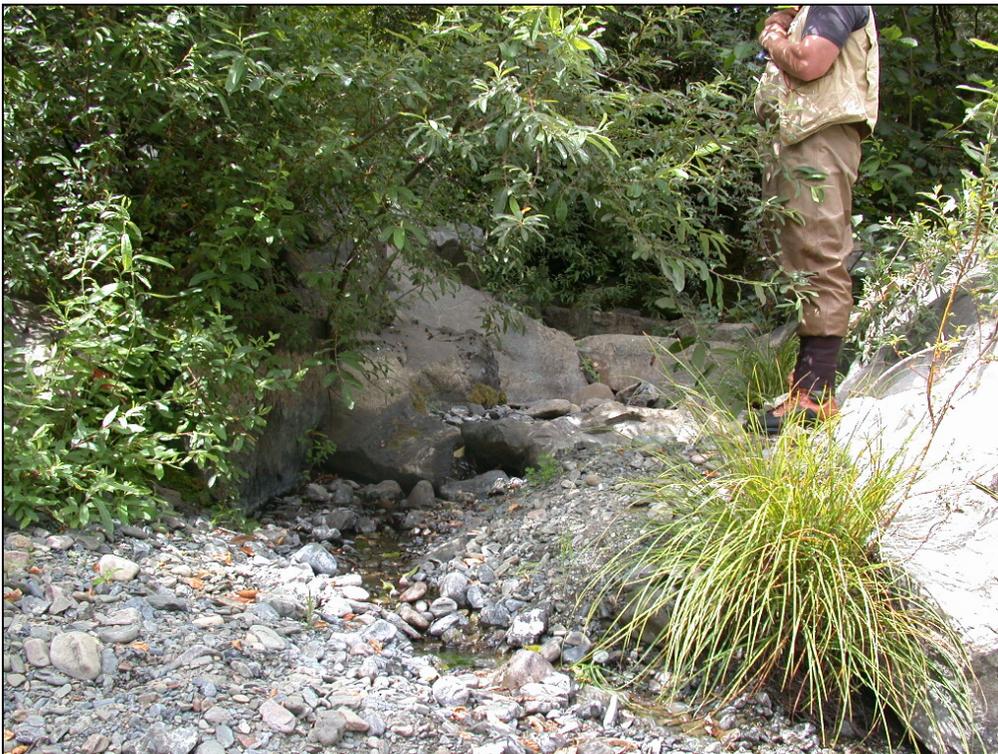
Figure 2. Mouth of Blanton Creek, August 16, 2006.

Additional stream surveys and habitat inventories were conducted on Blanton Creek by CDFW in early June, 1991 and again in June, 2006. These surveys noted approximately ten pool enhancement structures performing well in both 1991 and in 2006, as well as a functioning fishway built at the mouth in 1991. Passage barriers formed by debris jams were eliminated. In contrast to earlier surveys, the pool to riffle percent occurrence ratio had improved to approximately 1:1, but pools made up only 21 and 25 percent of the stream length in 1991 and 2006 respectively. The average residual pool depths were 1.8 feet in 1991 and 2.2 feet in 2006. The increase in pool habitat and pool depths noted in 2006 compared to 2001 may signal successful function of in stream habitat structures. In addition, cobble embeddedness measurements also showed a trend towards improvement of spawning gravel suitability, but there are still signs of bank instability and erosion that delivers fine sediments to the channel. Stream side canopy had increased to approximately 88 percent canopy over water in 2006 compared to 66 percent 1991. However most of the shade is produced from understory canopy. There is still a shortage of large redwoods capable of providing overstory shade and LWD as channel forming elements and instream shelter. Qualitative electrofishing surveys in 1991 and 2006 did not find

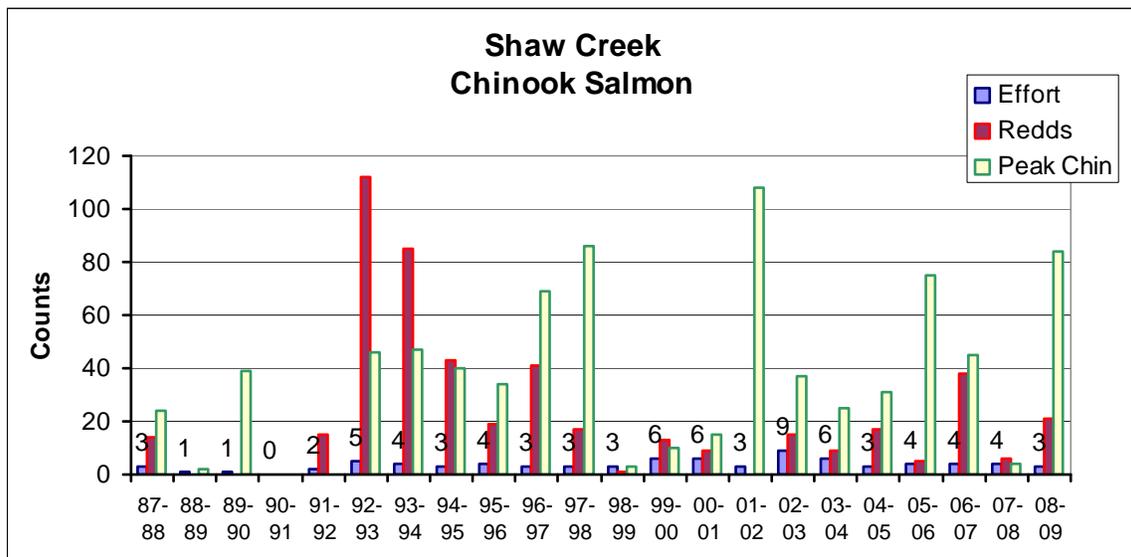
Figure 3 displays the results of CDFW Shaw Creek Chinook salmon carcass surveys during the years of 1987 to 2009. Linear regression analysis and ANOVA tests of Shaw Creek spawner survey data indicate no significant change or trend in the redd numbers ($R^2=0.024$, P value=0.486) or peak numbers of Chinook salmon ($R^2=0.104$, P value=0.143) observed from 1987 to 2007. Number of survey efforts shown by the blue bars are also displayed numerically.

Figure 3. CDFW Shaw Creek Chinook salmon carcass surveys from 1987 to 2009.
