Appendix B

Lower Subbasin Historical Stream Field Notes and Spawner Survey Data

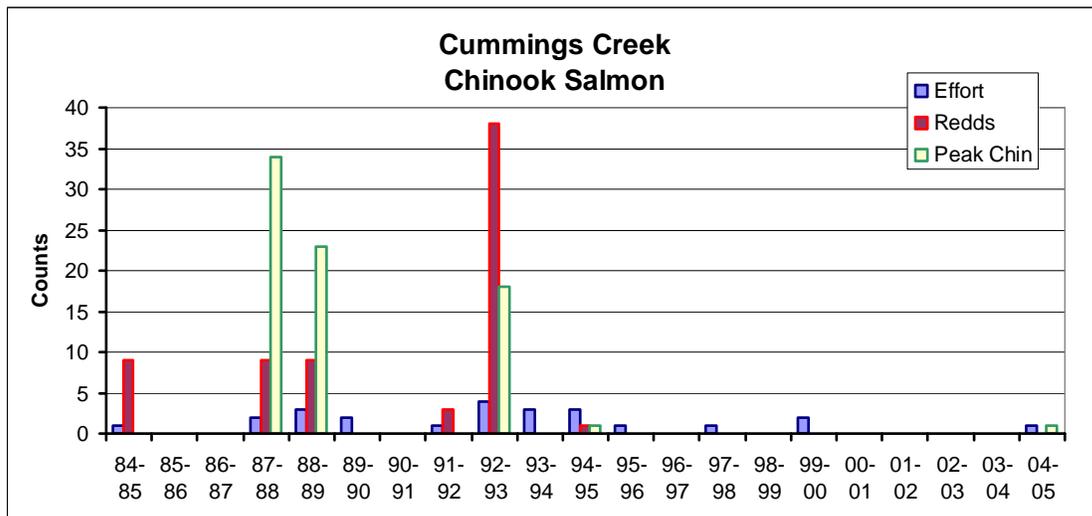
Figure 1. CDFW spawner survey data of Chinook salmon from 1984 to 2005.

Spawner surveys were conducted in Cummings Creek from 1984 to 2005 (Figure 1). Efforts varied from year to year and during several years no surveys were conducted.

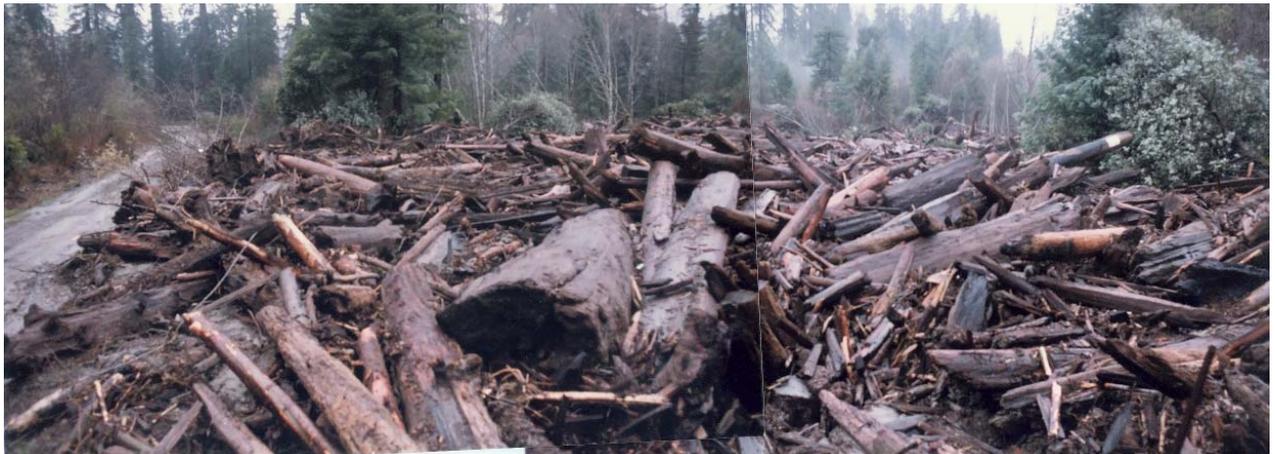
Figure 2. Debris torrent buries lower Heley Creek in 1983. The site is located approximately 1100 feet up Redwood House Road from HWY 36.

In 1983 after heavy rains a debris torrent flooded Hely Creek with large cull logs, slash and sediment (Figure 2) The probable source of the debris torrent was noted as a tributary involved in recent harvest activities (CDFG 1983).

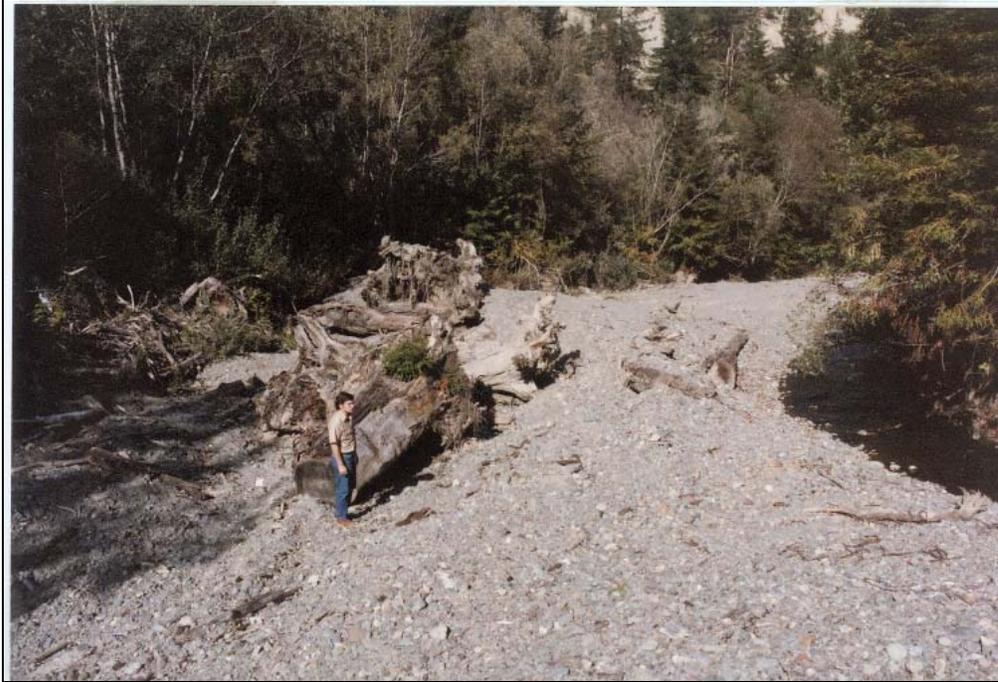
Figure 3. After clean up of debris torrent in Hely Creek. Photo taken in 1983.

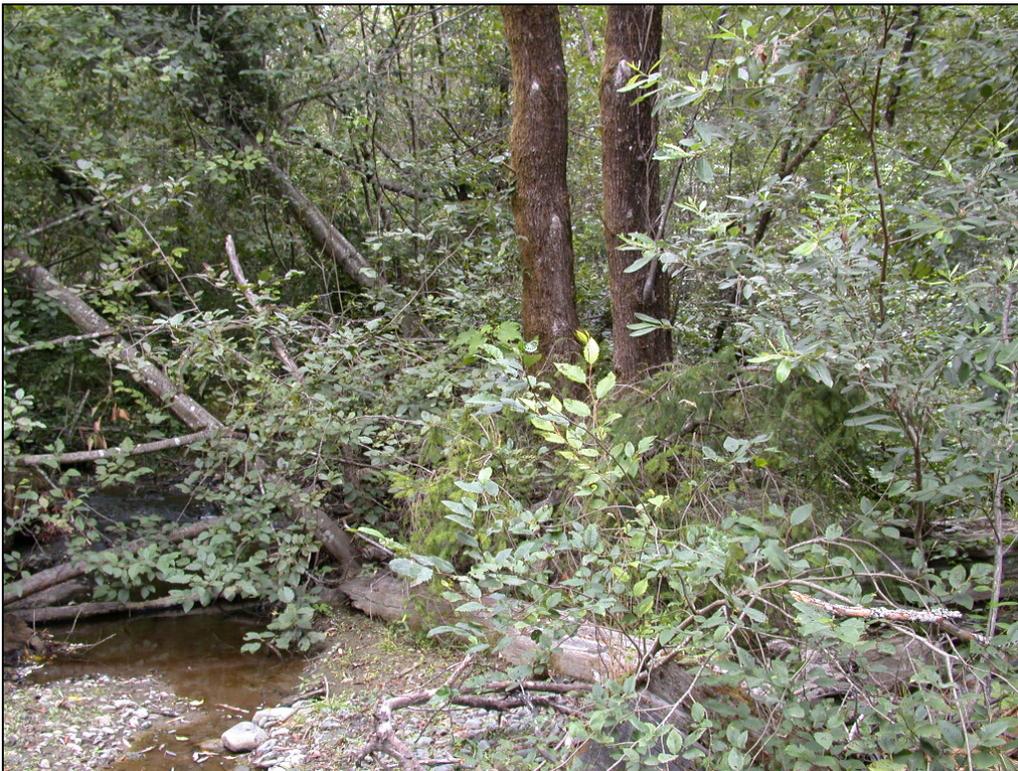
Figure 4. Riparian vegetation encroaches in Hely Creek channel. The stream forms a braided shallow channel around small islands of sediment and vegetation. Photo taken in 2006.

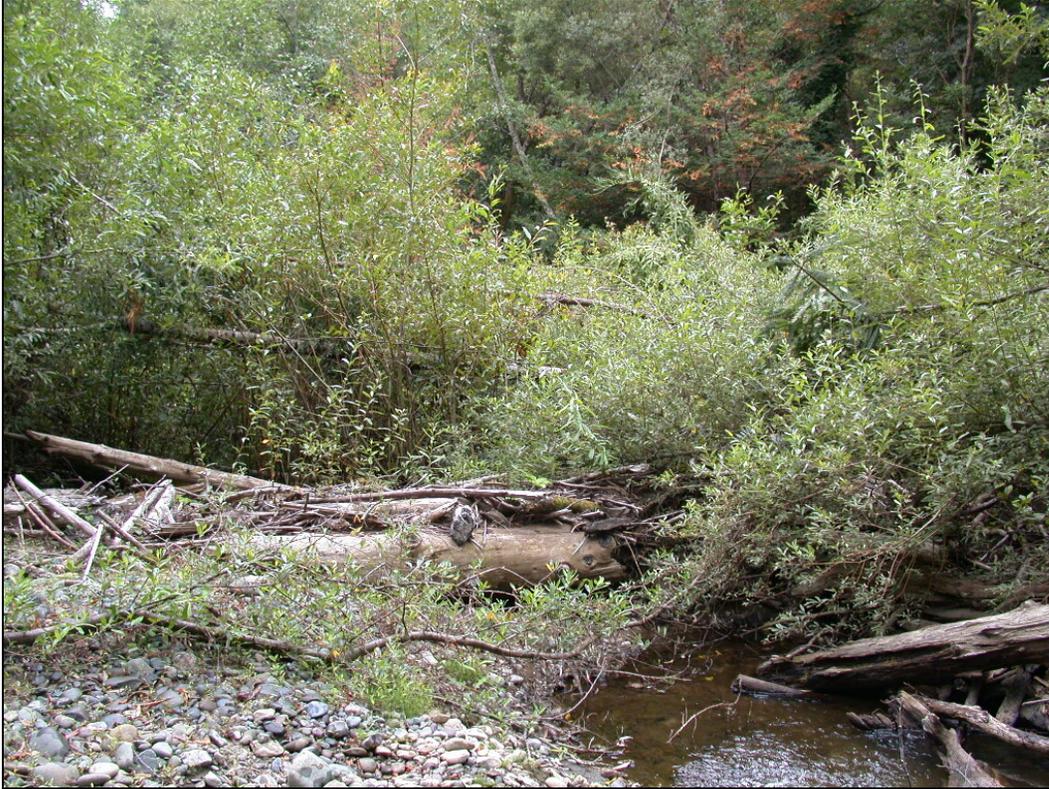
Figure 5. Hely Creek, photo of vegetation, gravel island and debris blocking channel.

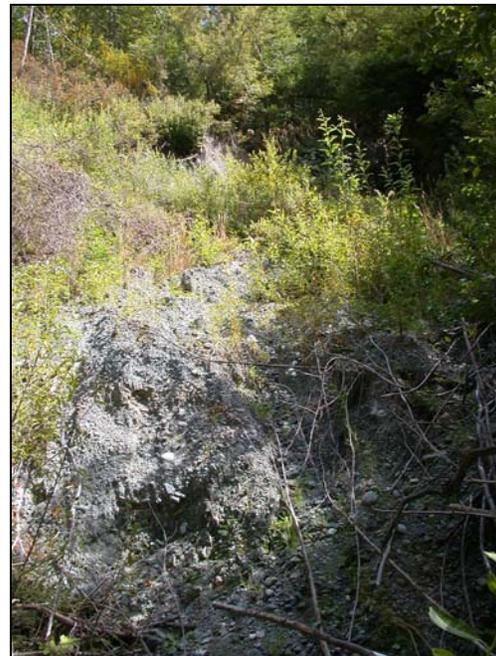
Figure 6. Hely Creek (~1600 feet above Highway 36) showing signs of high delivery of fine sediments in 2006.

At extremely high fine sediment loading, the entire channel may become buried by a blanket of fine sediment. Hence the spatial distribution of fine sediment can indicate the relative magnitude of the fine sediment load, but the calibration of this indicator will vary with channel type and other factors such as the local geology (Schnackenberg and MacDonald 1998).

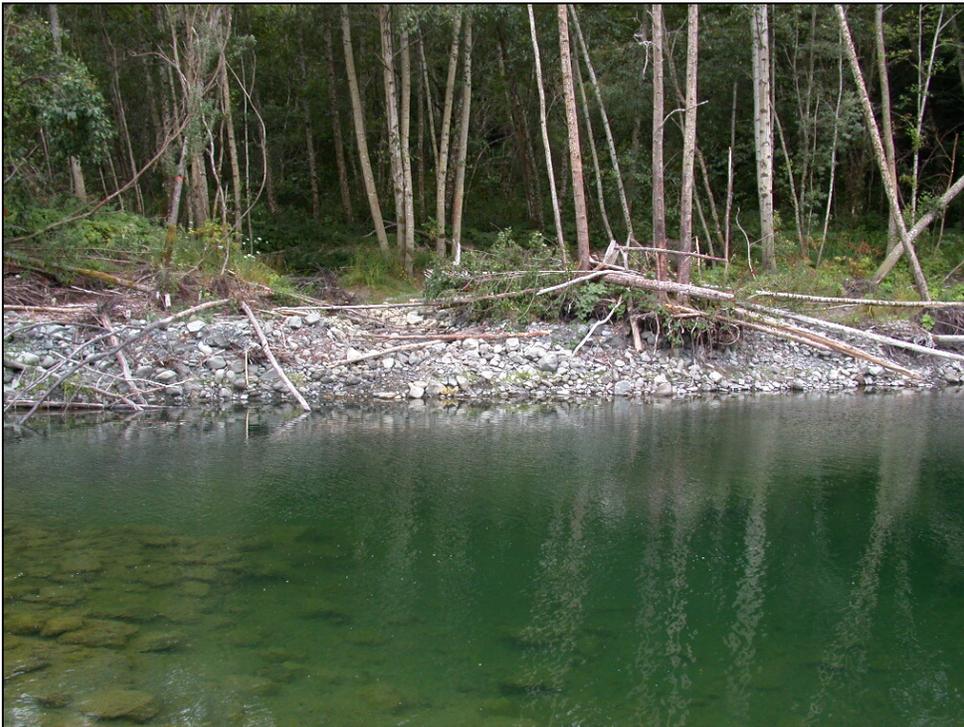
Figure 7. Photo of confluence of Root Creek and Van Duzen River. Fish access into Root Creek may be limited during low flows by sediment accumulations at creek mouth.

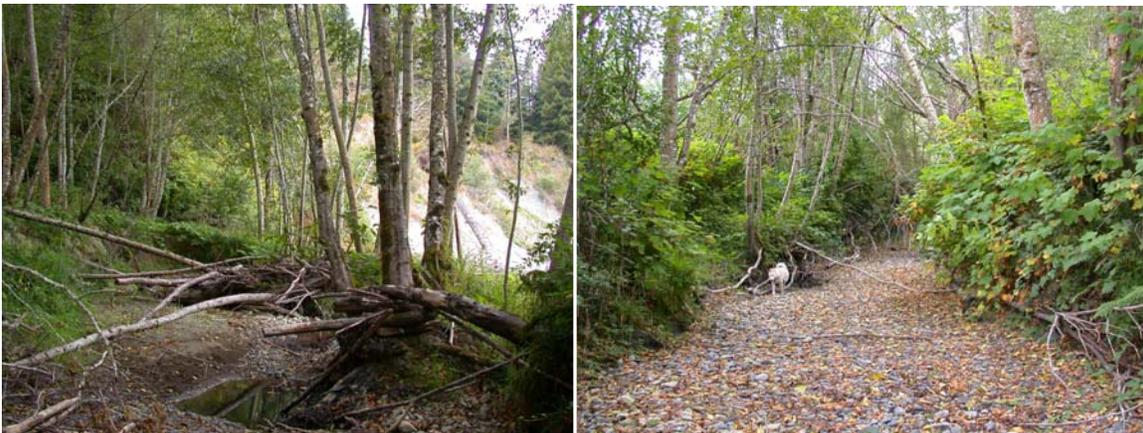
Figures 8 and 9. Lower Root Creek, just upstream of mouth (left) and dry cobble substrate channel about 50 feet further upstream (right). Photos taken August 29, 2006

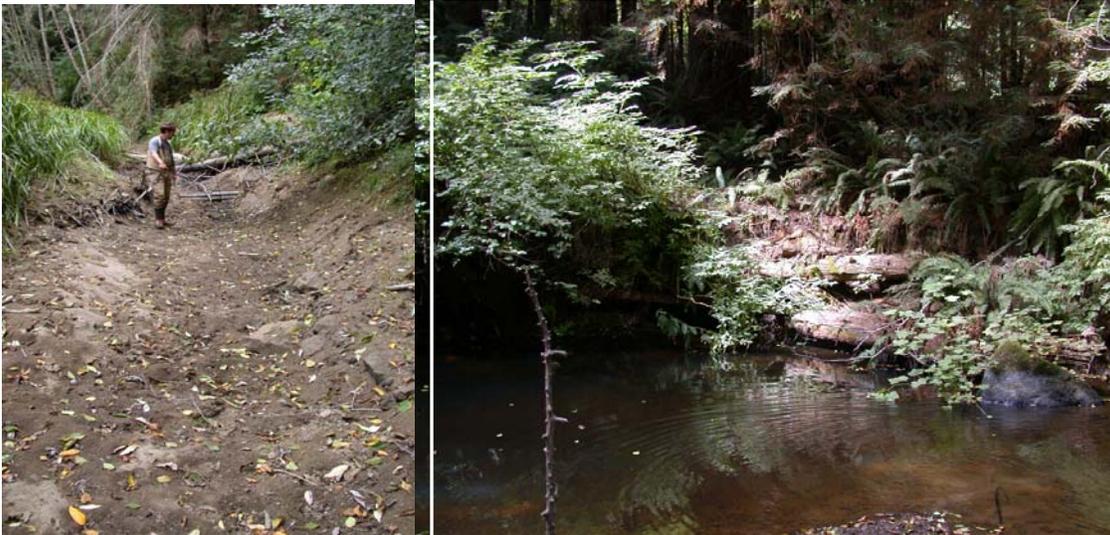
Figures 10 and 11. Lower Root Creek transition reach. Channel changes from dry cobble bottom to silt laden reach (left). Further upstream (RM 0.5) flows form pool habitat (right). Photo taken August 29, 2006.

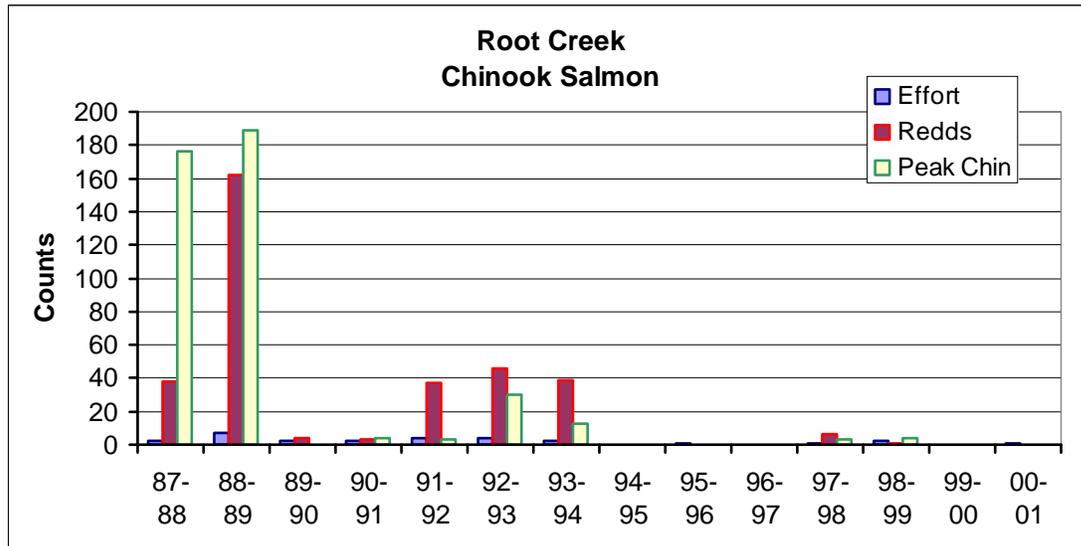
Figure 12. CDFW spawner survey data of Chinook salmon from 1987 to 2000. No data recorded in 1994-95, 95-96, 96-97, 99-00, and 00-10.

Spawner survey data collected by CDFW from 1987- 2000 show relatively large runs of Chinook salmon in Root Creek in 1987 and 1988, with a count of 176 and 188 respectively (Figure 12). In 1988, a total of 162 redds were counted which is at least 4-fold greater than any other survey year. The highest level of effort of any year in the survey also occurred in 1988. Number of redds and Chinook were dramatically lower from 1989-1990. The number of redds counted in 1989 and 1990 was five and four respectively. The number of Chinook counted in 1989 and 1990 was zero and six respectively. From 1991-1993, the number of redds increased and were consistent averaging 40 redds, however the number of Chinook ranged from three to 30 to 12 respectively. The number of redds and fish counted dropped to zero or near-zero levels in 1995, 1997, 1998, and 2000 (no spawner surveys were conducted in 1994, 1996, and 1999); however the number of surveys per year (measured by effort) was reduced following 1993 which may account for some of the declines. In addition to 1994, 1996, and 1999, no spawner surveys were conducted following 2000; efforts ceased due to access problems, lack of fish, and logistical issues. Access to Root Creek requires crossing the mainstem Van Duzen River which is often dangerous in the spawning season due to high river flows.

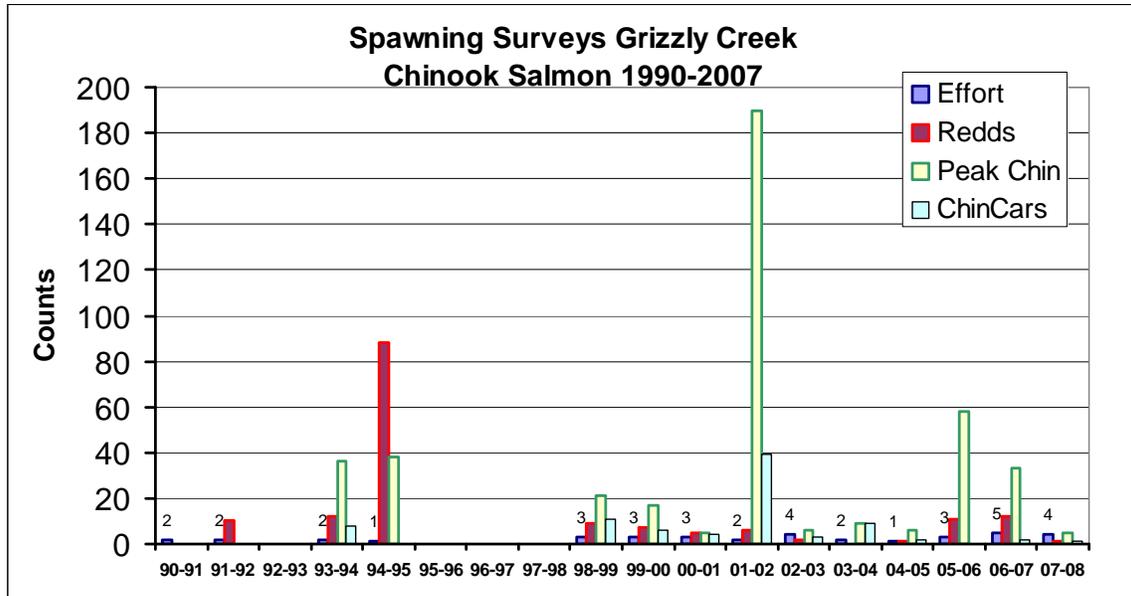
Figure 14. CDFW Grizzly Creek spawner surveys to determine counts of Chinook redds (Redds), live Chinook (Peak Chin) and Chinook carcasses (ChinCars) between 1990 -1995 and 1998-2008 (survey efforts expanded between 1998 and 2008).

Grizzly Creek's confluence with the Van Duzen River is located approximately RM 23.1. Grizzly Creek is an extremely important Chinook-producing stream. Spawner surveys have been conducted by CDFW from 1982-1983, 1990-1995, and from 1998-2008 (Figure 14). In a 1982-83 CDFW spawner study of 40 Eel River tributary streams, Grizzly Creek had the highest estimate of Chinook carcasses of all tributaries in the Eel River Basin. CDFW estimated there were approximately 266 ± 104 Chinook carcasses in Grizzly Creek, based on the recovery of 27 of the 61 marked carcasses from a total of 119 of carcasses examined. Other survey years with high Chinook counts include 90 redds in 1994-95, 190 live Chinook in 2001-02, and nearly 60 live Chinook observed in 2005-06.
