Small Watershed, Big Restoration

Rocky Gulch Salmonid Access and Habitat Restoration Project

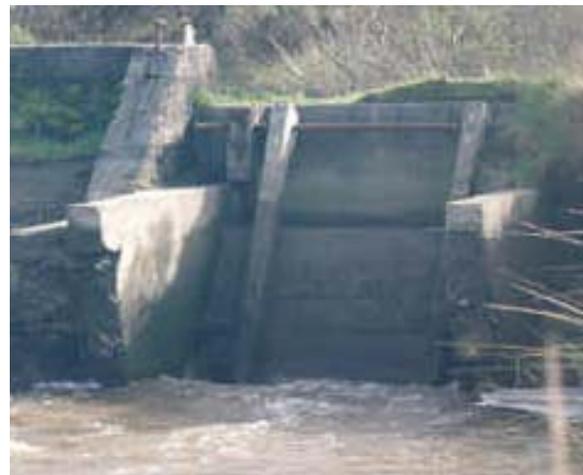
Figure 2. The old tide gate during an outgoing tide showing the gate partially open but a barrier to adult fish migration.

Rocky Gulch has faced many hardships, in the form of logging, railroad grades, highways, levees, timber mills, and residential developments. Entire tidal marshes were converted from wetlands to pasture by the installation of a tide gate to prevent the flow of salt water to the fields. However, the heavy top-hinged door excluded both salt water and fish (Figure 2).

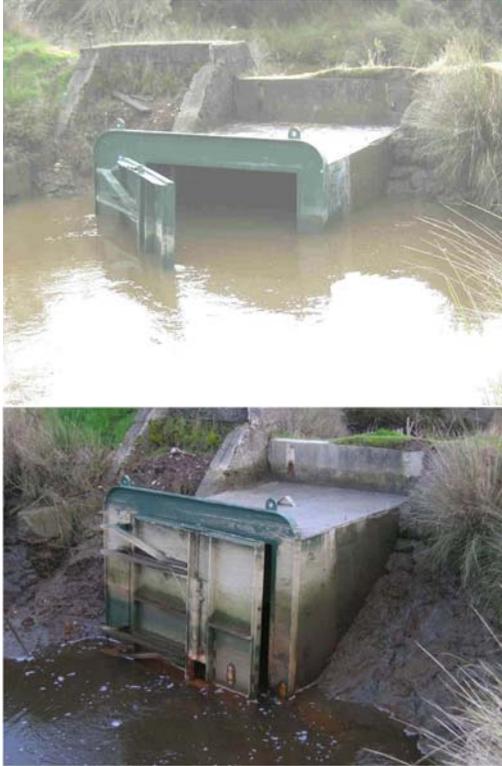
Figure 3. Top: the new side-hinged tide gate during the outgoing tide showing the door wide open to fish passage. Bottom: the new tide gate at low tide showing the auxiliary door which is always open.

As part of the project, the antiquated tide gate was replaced with a new "fish-friendly" gate. A side-hinge allows the door to open easily with the outgoing tide, allowing unimpeded fish passage (Figure 3). An auxiliary door allows fish passage and a controlled amount of sea water to pass through the gate even when the door is closed (Figure 3). Many benefits have been attributed to daily seawater intrusion past the gate, but undoubtedly the most exciting came in August 2005. Following the first winter with the new tide gate in operation, coho salmon were positively identified in Rocky Gulch for the first time in nearly 40 years (Figure 1)! Not only juvenile coho salmon, but rainbow and coastal cutthroat trout were found as well.
